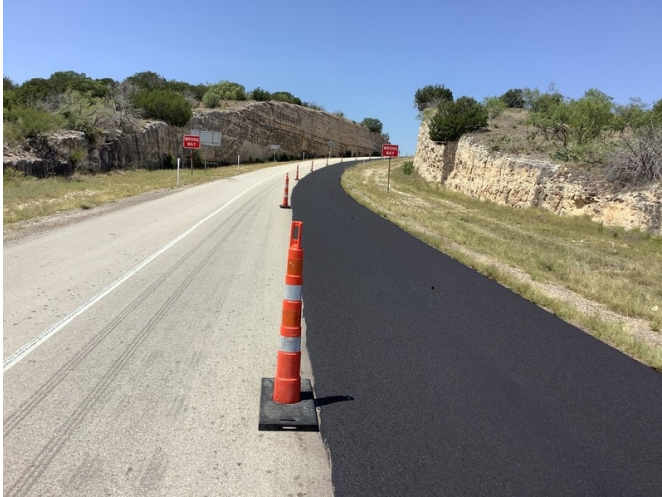
Micro Surfacing is being applied to Interstate I-10 in Ozona, Texas.

On August 3, 2020, the contractor began the process of applying the micro surfacing solution, at 22 pounds per square yard along the 96 lane mile stretch of I-10. Exit and entrance ramps throughout the project also received micro surfacing. The treatment was applied in two-mile increments, with traffic shifted to one lane during application. The fog seal was applied on the shoulders at 0.10 gallons per square yard. Section by section, both treatments cured in less than an hour, at which time traffic was returned. The entire project was completed by September 1.

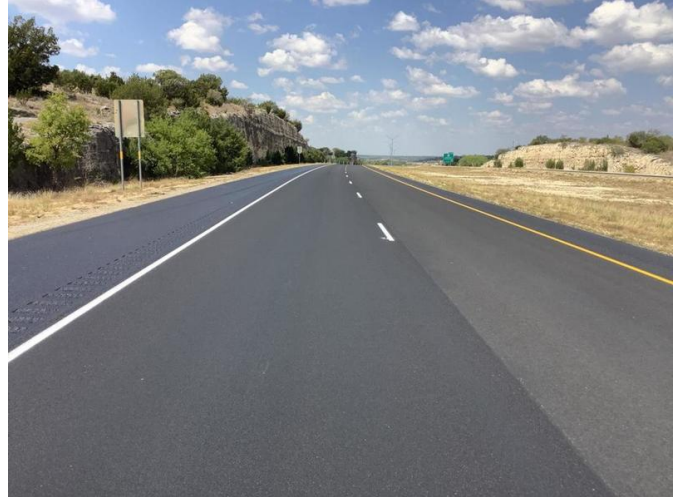
Completed Micro Surfacing project in Ozona, Texas maximized surface friction.
