## Using Optimized Solutions for Extreme Soil Conditions

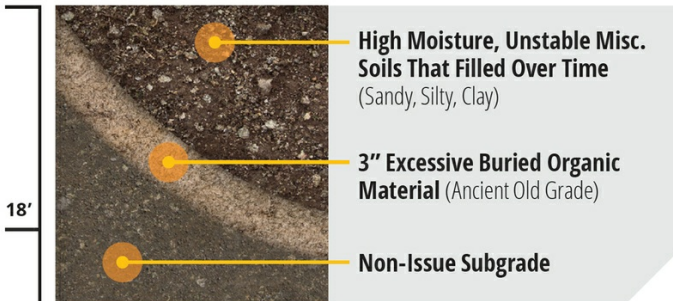
## THE PROBLEM

Engineers were faced with solving foundation issues caused by improperly placed fill soil with high moisture content that had been placed atop 3' of buried organic material, reaching depths of up to 18'. This combination made standard foundation construction impossible, prompting engineers to explore alternate solutions like every costly caissons or worse yet, total removal and replacement.

### CURRENT GRADE
