This trackless bond coat was shot for ALDOT on SR-102 in Walker County. Full proper coverage of bond coat and quick return to paving are features for this treatment.

BACKSTORY:

The project is located on SR-102 in Walker County. This is located in the ALDOT West Central Region. The weather started off in the mid 50s and rose to the low 70s.

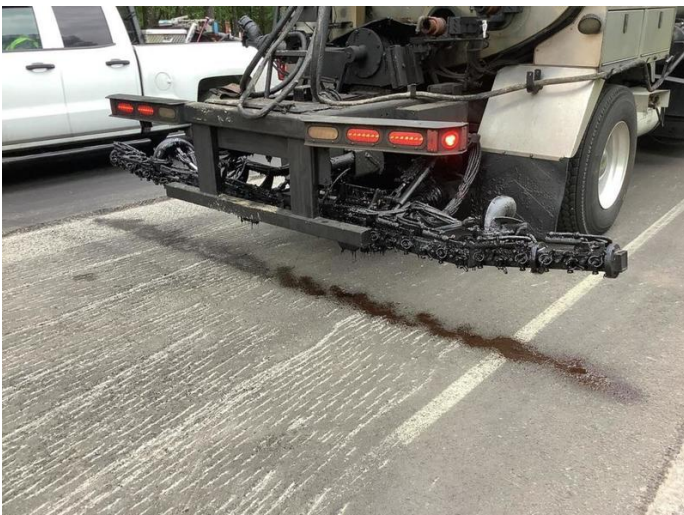
Prior to shooting trackless tack and checking each nozzle.

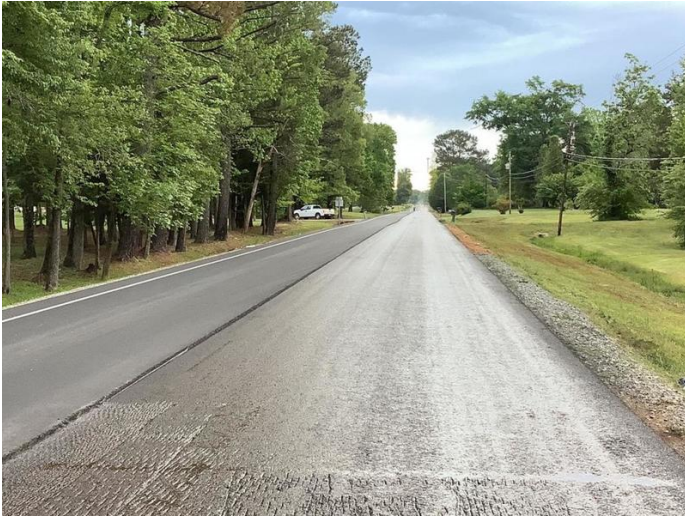
Uniform Shot Rate (Not Broken)

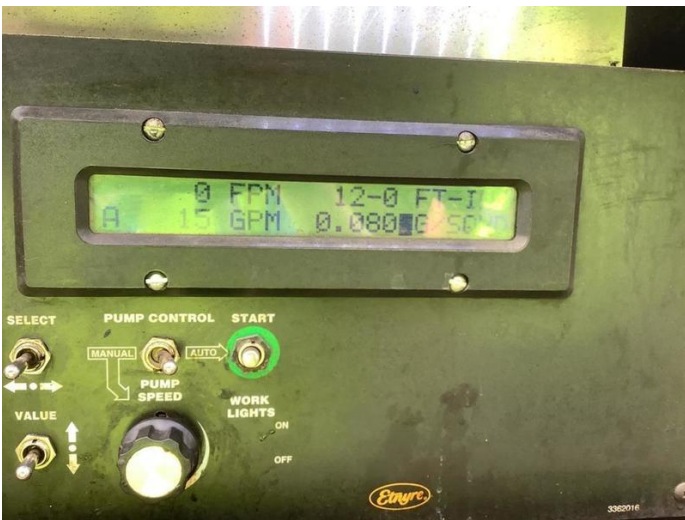
Shot Rate on Distributor Computer 0.08gal/sy

The Trackless tack was shot at 0.08gal/sy. The contractor used an Etnyre Distributor with #1 nozzles. Etnyre says this size nozzle can shoot a rate of 0.05-0.20gal/sy. The correct nozzle size used on this project, provided great uniform coverage of the bond coat throughout the project. This would prove essential to bond the pavements so that layers would perform as one monolithic pavement.

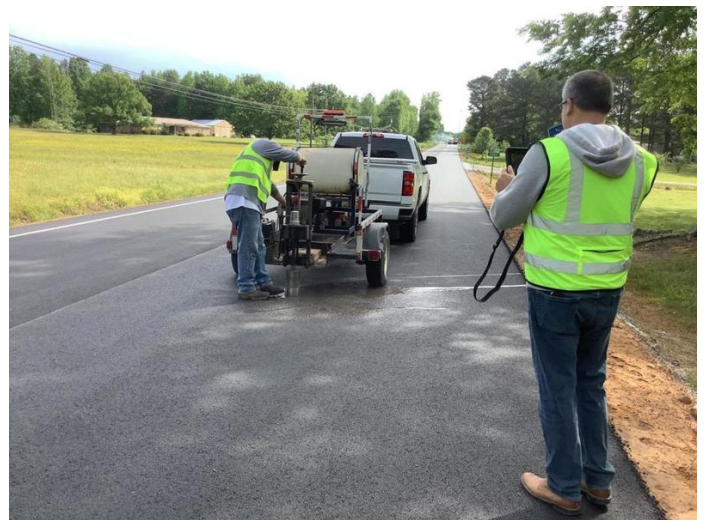
Cutting Cores

Cores were taken in 500' intervals for this project. The bond strengths averaged over 200psi, proving that the trackless tack provided a very strong bond between the pavement layers. The minimum passing for core bond strengths is 100psi.

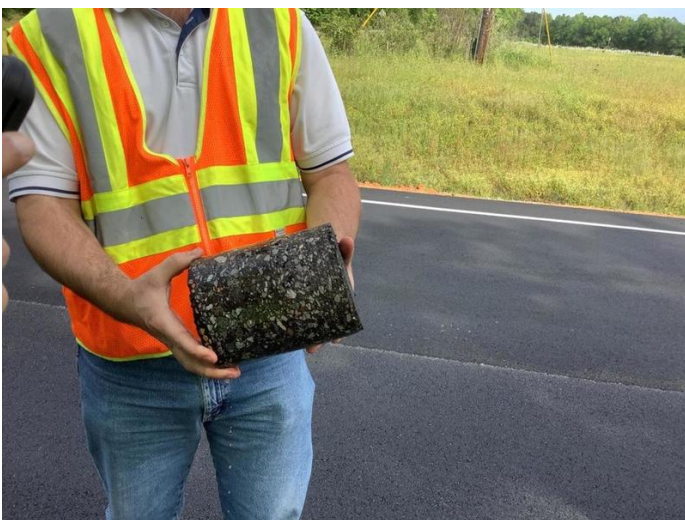
Core Cut showing tack bonded Pavement Layers

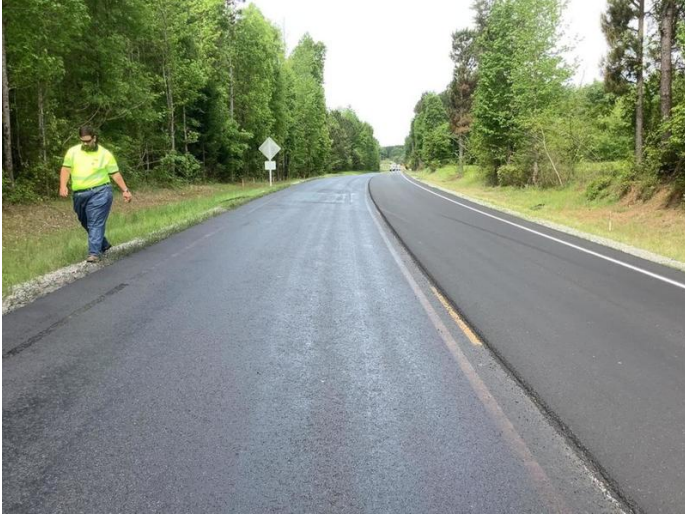
Perfect Uniform Coverage of Broken Trackless Tack
