Victoria, Australia utilizes pavement preservation techniques for higher quality roads, supporting heavy traffic, with a lower project cost.

BACKSTORY:

A section of arterial road in Benalla, Victoria experiences a heavy flow of both commercial and residential traffic, with more than 9,000 vehicles per day. The wear and tear from the high volume of traffic, and the turning and torque of heavy vehicles required a massive maintenance program to repair and extend their lifespan.

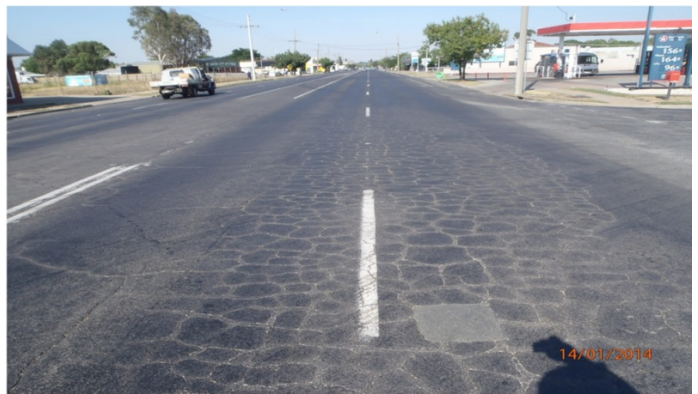
Pre-existing Condition - January 2014

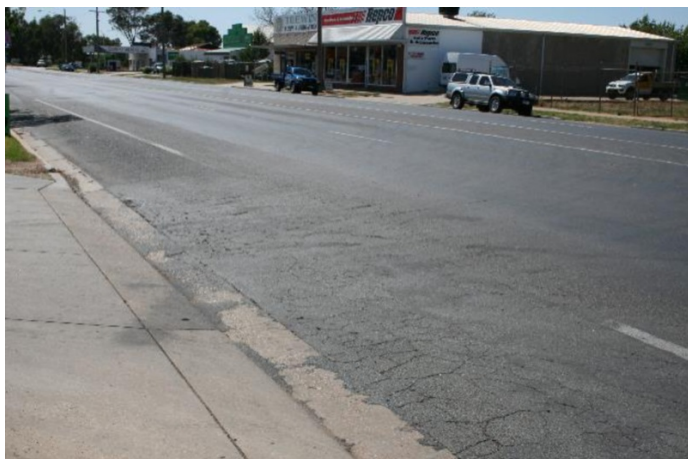
Pre-existing Condition - January 2014

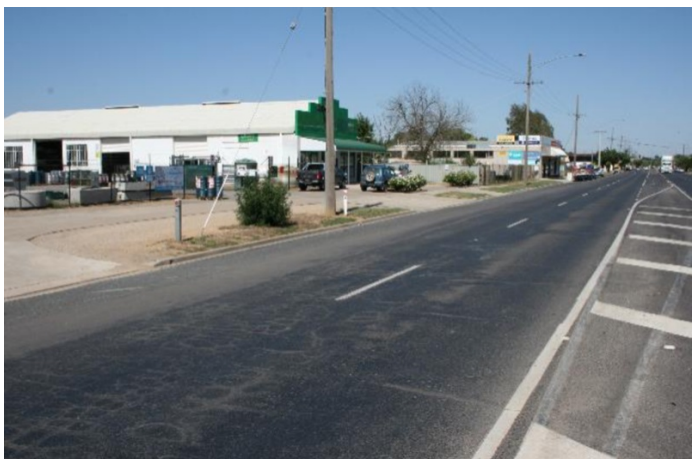
Pre-existing Condition - January 2014

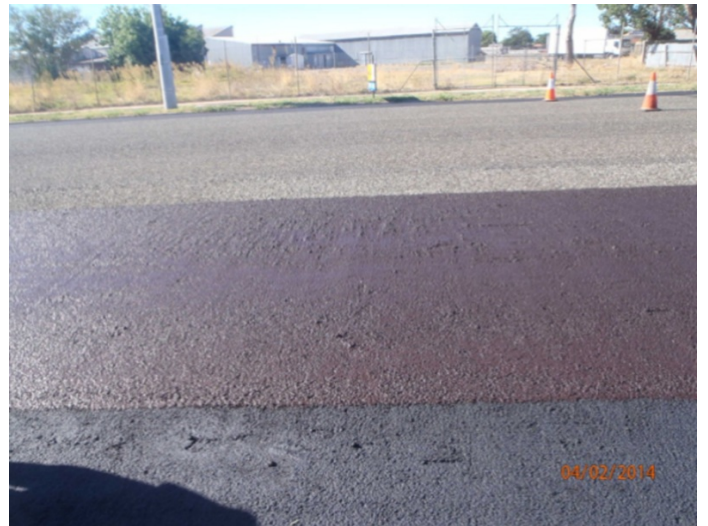
Installing the Micro Surfacing

North Eastern Maintenance Alliance teamed with Downer Group to provide a preservation treatment using a Polymer Modified Binder (PMB) Spray Seal, overlaid with a Microsurfacing SFT (Suspended Fibre Technology) Cape Seal, cutting expenses, emissions and time. This type of treatment provided a cost effective, highly flexible, waterproof film coupled with a hard wearing surface to accommodate high volumes of vehicles, turning traffic and sound reduction. Six years after completion, the road is maintaining a high condition with minimal wear.

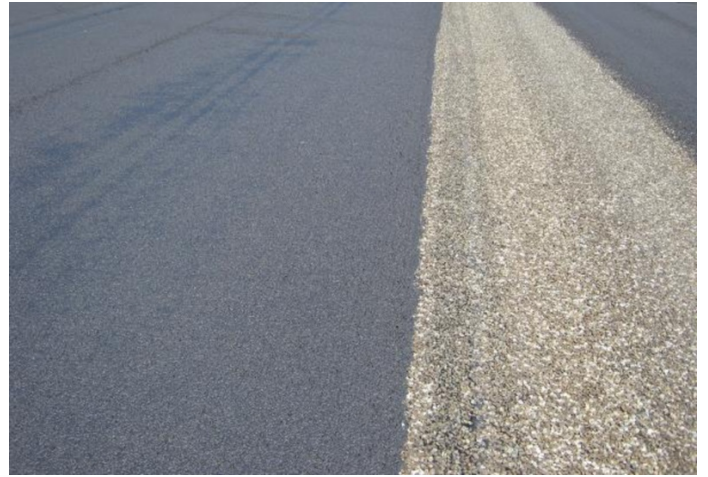
Installing the Micro Surfacing

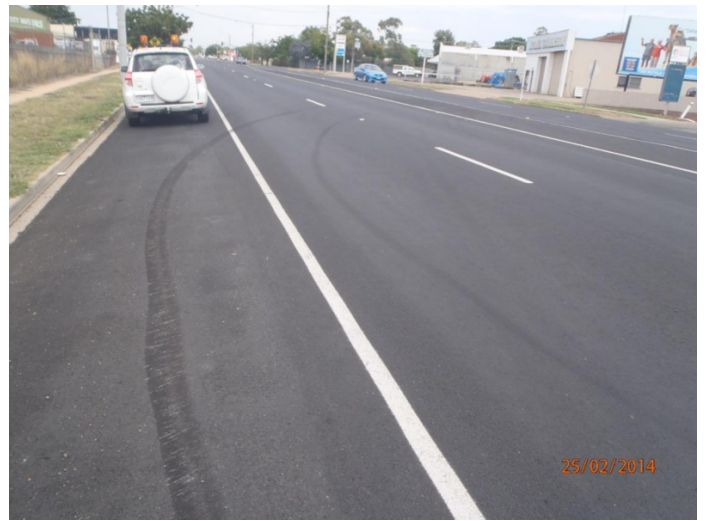
Completed Surface 2014

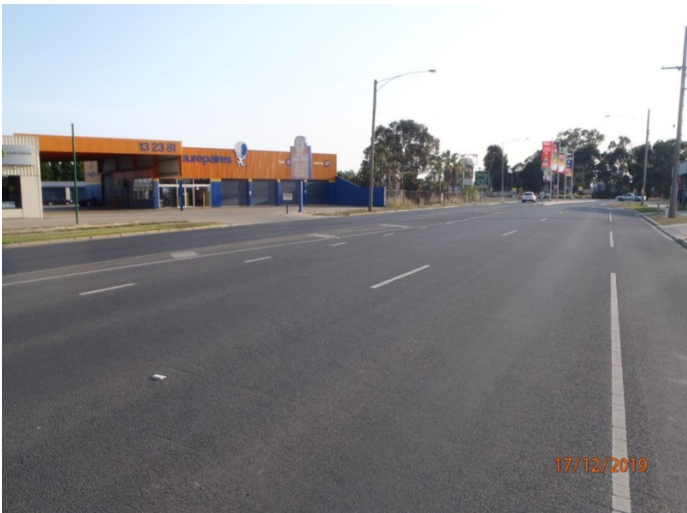
Performance Review December 2019

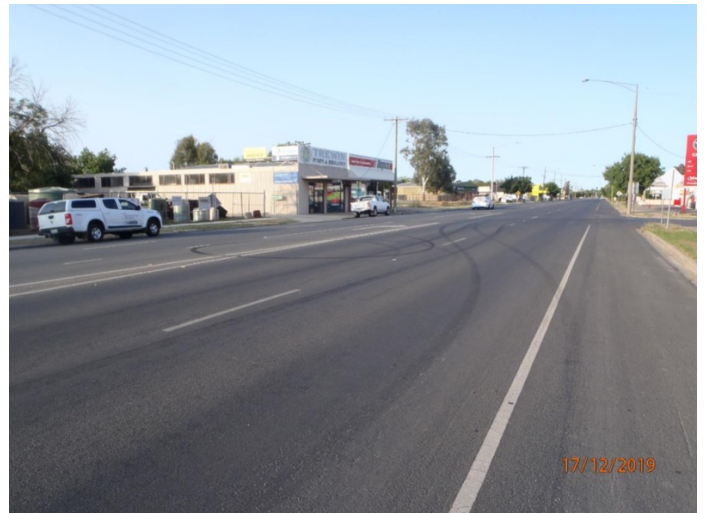
Performance Review December 2019
