#### BACKSTORY:

A distribution center that has hundreds of heavy semi loads coming in and out each month needs a strong and durable driving base. The transport shipping yard's pavement was deteriorating and showing signs of deep subgrade failure. Soil samples determined that Base Stabilization with emulsion would be a good technique to fix the shipping yard.

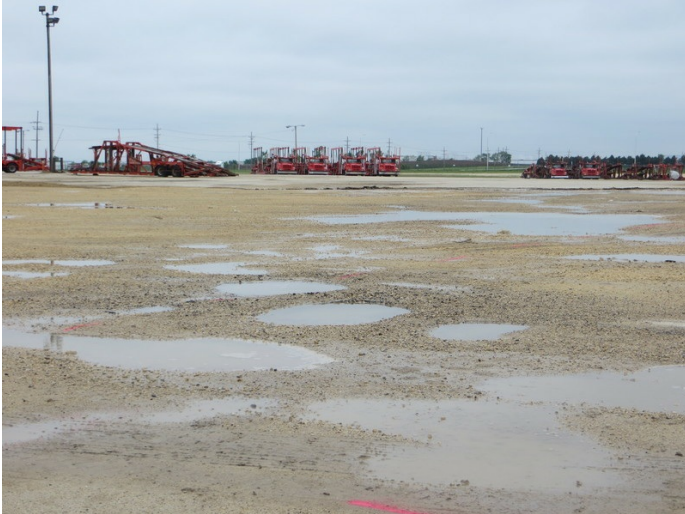
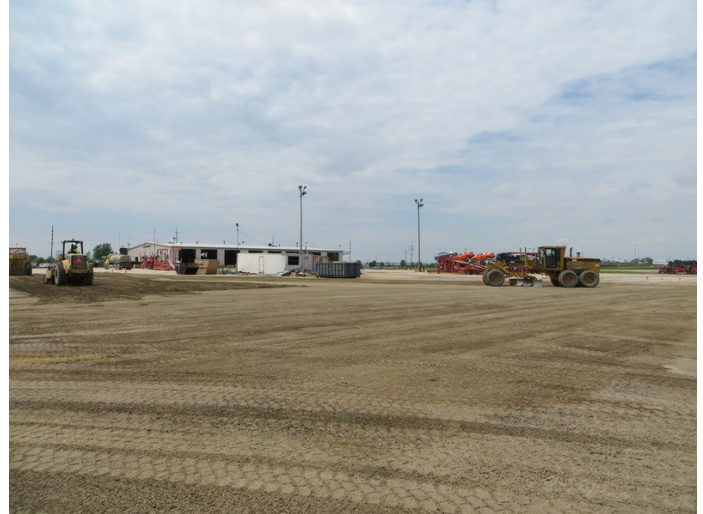
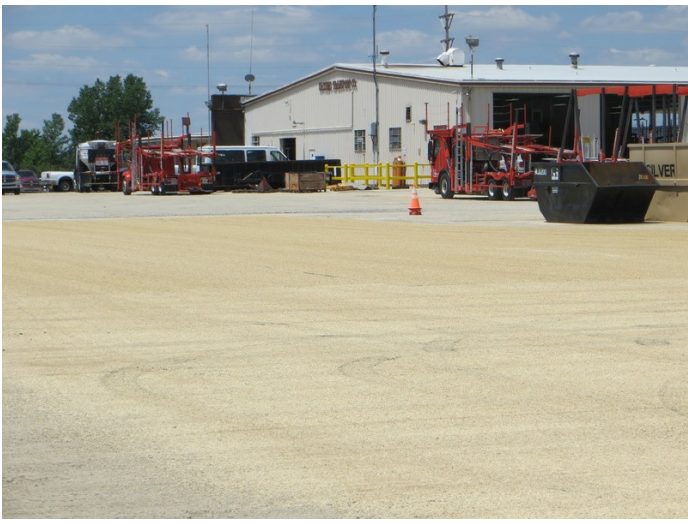
#### PHOTOS:

While performing test strips to verify the mix design would perform, the field crew found heavy clay in the base course. The aggregate base thickness was not as deep as they had determined from the initial soil samples. Emulsion was not going to be a suitable candidate to stabilize the base because of the high clay content.

An alternate approach using 5% Portland cement tilled at 12" was tested to determine quality performance. It was proven to stabilize the existing aggregate and clay base and accepted by the soil engineer as well as the owner to complete their repair. The Base Stabilization with Cement gave the shipping yard the strength and durability it needed to withstand the heavy semi loads, and it worked so well that they have used it on other projects at their facility.
