This trackless bond coat was shot for ALDOT on SR-102 in Walker County. Full proper coverage of bond coat and quick return to paving are features for this treatment.

The project is located on SR-102 in Walker County. This is located in the ALDOT West Central Region. The weather started off in the mid 50s and rose to the low 70s.

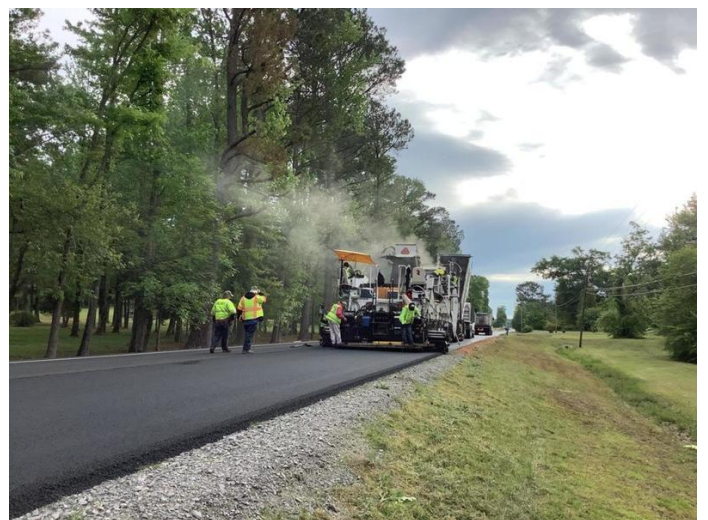
Paving Hot Mix
