## Using Optimized Solutions for Extreme Soil Conditions

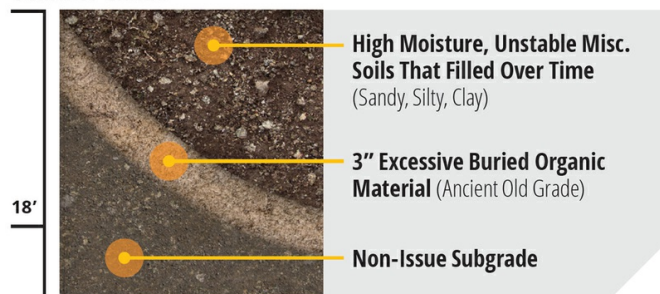
### THE PROBLEM

Engineers were faced with solving foundation issues caused by improperly placed fill soil with high moisture content that had been placed atop 3' of buried organic material, reaching depths of up to 18'. This combination made standard foundation construction impossible, prompting engineers to explore alternate solutions like every costly caissons or worse yet, total removal and replacement.

**CURRENT GRADE**

18'

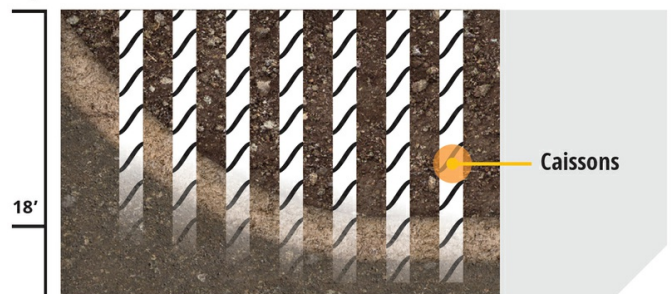
### THE PROPOSED APPROACH

Caissons were originally specified to support the foundation, reaching into the stable subgrade below. This support system would require a non-conventional underground piping and construction process; a method that is known to cause delays and increase construction costs. Rock Solid value-engineered a Soil Stabilization process to re-use existing material and avoid non-conventional construction methods, saving money and time.

0'  
18'  
Caissons
