BACKSTORY:

A distribution center that has hundreds of heavy semi loads coming in and out each month needs a strong and durable driving base. The transport shipping yard's pavement was deteriorating and showing signs of deep subgrade failure. Soil samples determined that Base Stabilization with emulsion would be a good technique to fix the shipping yard.

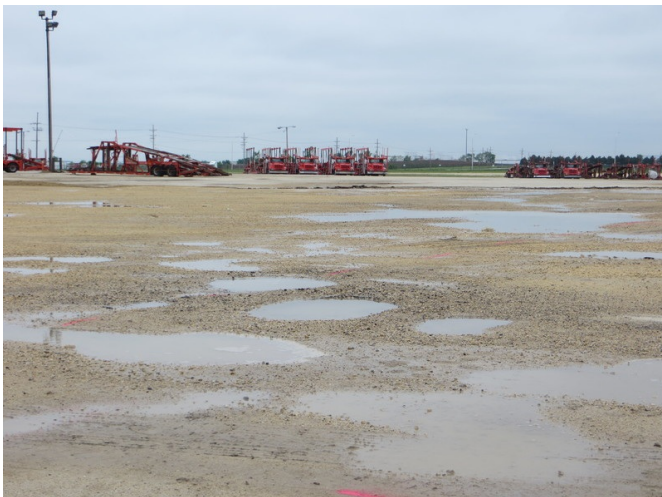
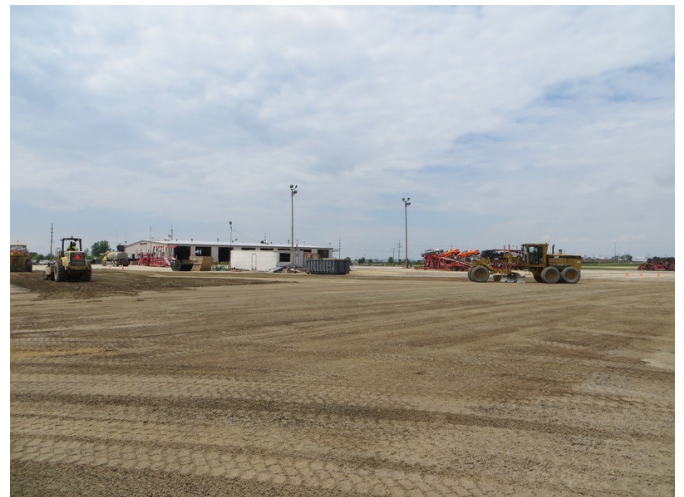
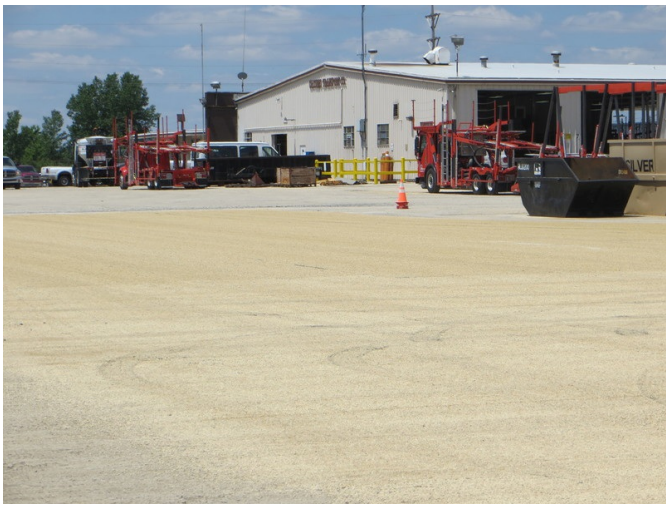
PHOTOS:

While performing test strips to verify the mix design would perform, the field crew found heavy clay in the base course. The aggregate base thickness was not as deep as they had determined from the initial soil samples. Emulsion was not going to be a suitable candidate to stabilize the base because of the high clay content.

An alternate approach using 5% Portland cement tilled at 12" was tested to determine quality performance. It was proven to stabilize the existing aggregate and clay base and accepted by the soil engineer as well as the owner to complete their repair. The Base Stabilization with Cement gave the shipping yard the strength and durability it needed to withstand the heavy semi loads, and it worked so well that they have used it on other projects at their facility.
