Cold Central Plant Recycling allowed INDOT to repair and upgrade a major collector in Northeast Indiana. State Route 101 appeared to need surface repairs, but upon further investigation, a deeper treatment was needed in order to restore the roadway and create a safer route for both the local Amish traffic and regular vehicular traffic.

BACKSTORY:

State Route 101, a major collector for US-24, in Indiana Department of Transportation's (INDOT) Fort Wayne District was originally scoped to be treated with a single lift HMA overlay with excessive localized full-depth patching. This section of SR 101 measures approximately 8.6 miles long with an AADT of 2000 and is known for being heavily traveled by horse-drawn buggies from the surrounding Amish communities.

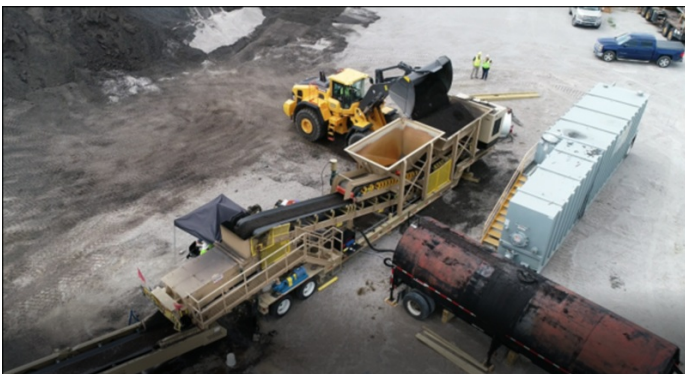
The nearby cold central plant being fed with RAP from the stockpile

The CCPR mix was produced utilizing engineered emulsion and the road's stockpiled asphalt millings at the central location, then loaded onto trucks and hauled back to the roadway where the mix was paved to a depth of 6.0 inches. 37,000 tons of CCPR mix was produced at a rate of 300 tons per hour and the paving of the CCPR mix took 16 days. Once the construction and the curing of the paved CCPR mix were completed, the roadway was profile milled and then a 2.0-inch 12.5mm Surface Mix was placed.

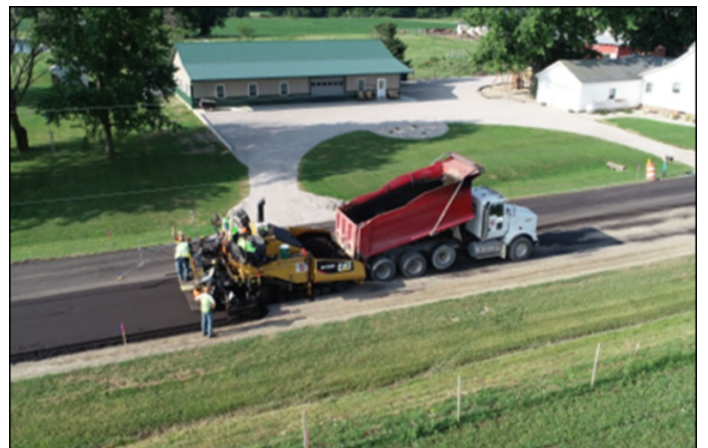
Paving of the 6.0-inch CCPR lift
