In 2005, Mississippi DOT preserved one of their most heavily trafficked highways, adding 14+ years of life while addressing friction, cracking and rutting-
- Today in 2020, the highway has required no further treatments.

BACKSTORY:

In 2005, 12 miles of Highway 61 in Tunica, Mississippi needed reprofiling and preservation due to high traffic (13,000 vehicles per day) leading in and out of their gambling district, the third largest in America.

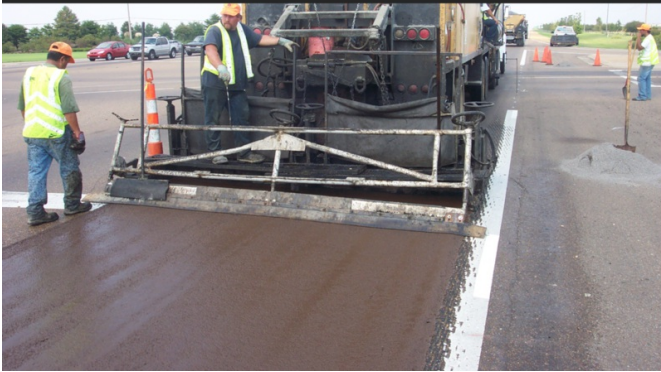
Photo Recap
2005 Micro Surfacing Application

MDOT worked with Vance Brothers, Ergon Asphalt & Emulsions, and Vulcan Materials Company through devastating weather conditions resulting from hurricane Katrina, to apply micro surfacing in two thin lifts with Type V aggregate and a micro surfacing emulsion (CSS-1HP), applied at 11.0% +/- 1.0%. The optimum emulsion content was engineered to sit on the lower side of the specified range to address rutting.

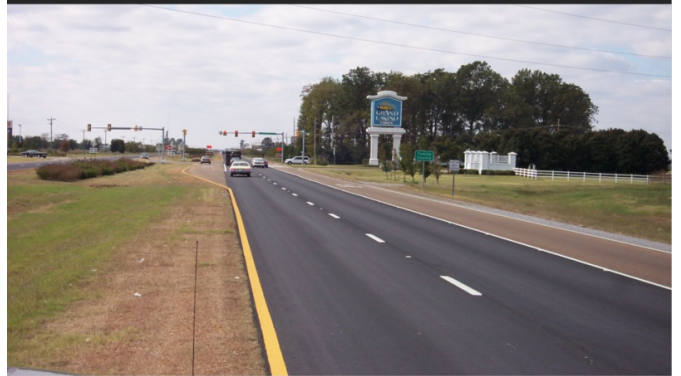
Photo Recap
2005 After Micro Surfacing Application

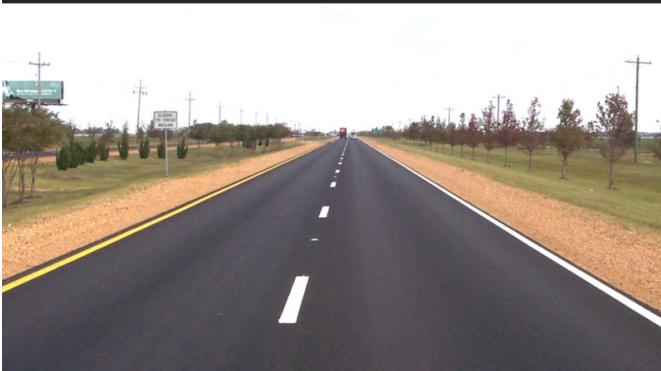
Photo Recap
2005 After Micro Surfacing Application

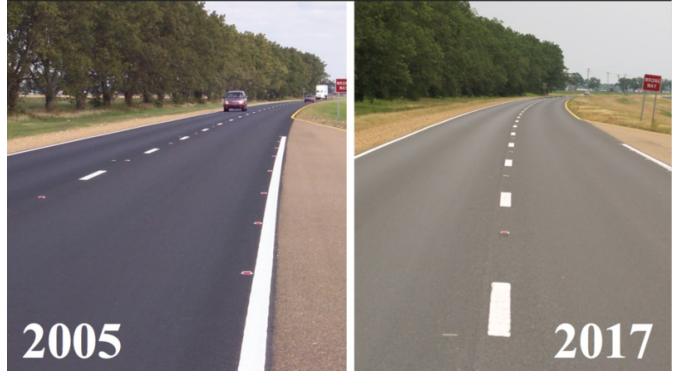
Photo Recap
2005 / 2017 Side-by-Side Comparison

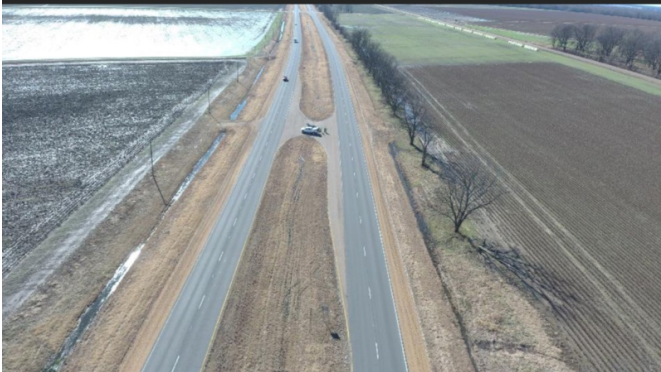
This process saved millions of dollars which could be allocated to other needs. Passengers have enjoyed a more durable wearing course which is able to withstand the heavy volumes of traffic. After 14 years the roads continue to hold, requiring no further treatments to date.

Photo Recap
2020 – Over 14 Years Post Application
