This trackless bond coat was shot for ALDOT on SR-102 in Walker County. Full proper coverage of bond coat and quick return to paving are features for this treatment.

The project is located on SR-102 in Walker County. This is located in the ALDOT West Central Region. The weather started off in the mid 50s and rose to the low 70s.

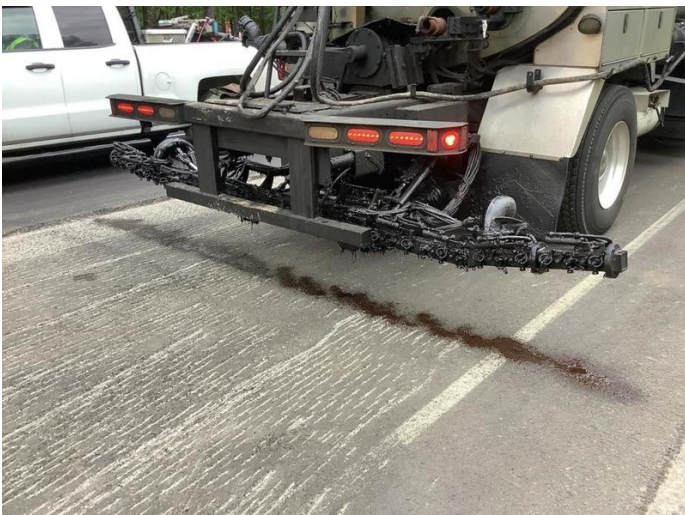
Prior to shooting trackless tack and checking each nozzle.

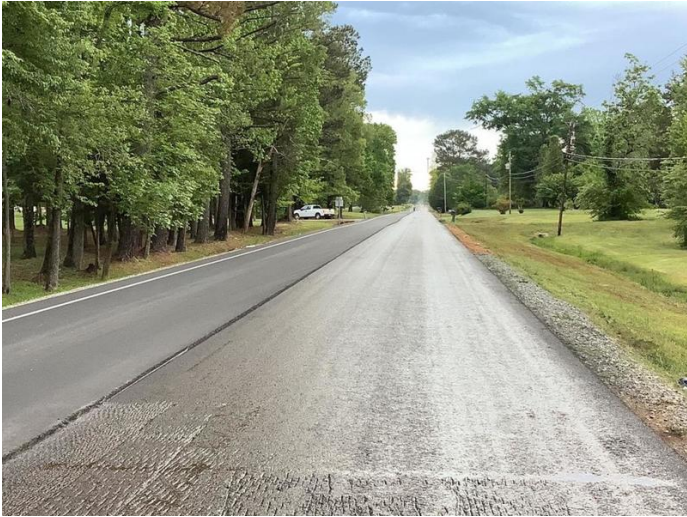
Uniform Shot Rate (Not Broken)

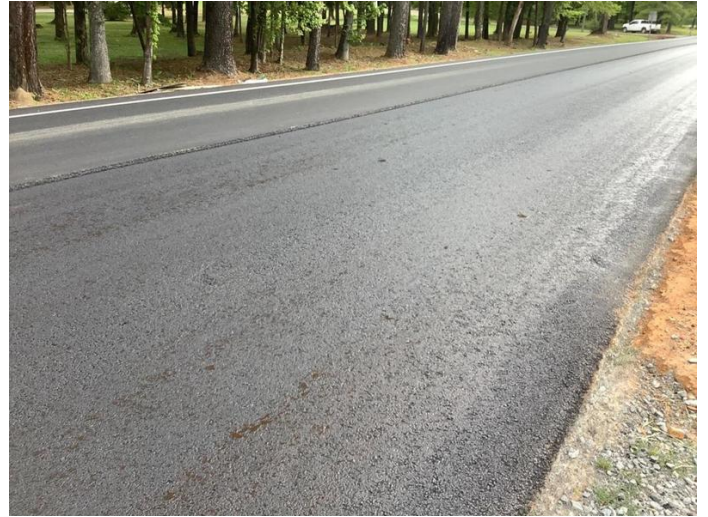
Broken Tack (Uniform Coverage)

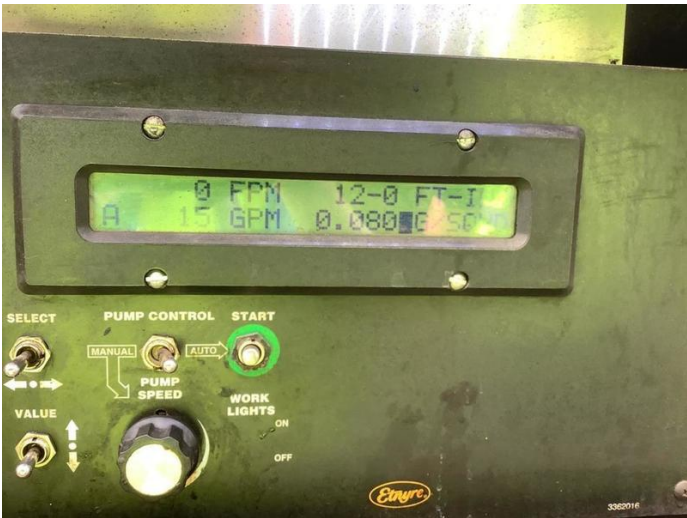
Shot Rate on Distributor Computer 0.08gal/sy

The Trackless tack was shot at 0.08gal/sy. The contractor used an Etnyre Distributor with #1 nozzles. Etnyre says this size nozzle can shoot a rate of 0.05-0.20gal/sy. The correct nozzle size used on this project, provided great uniform coverage of the bond coat throughout the project. This would prove essential to bond the pavements so that layers would perform as one monolithic pavement.

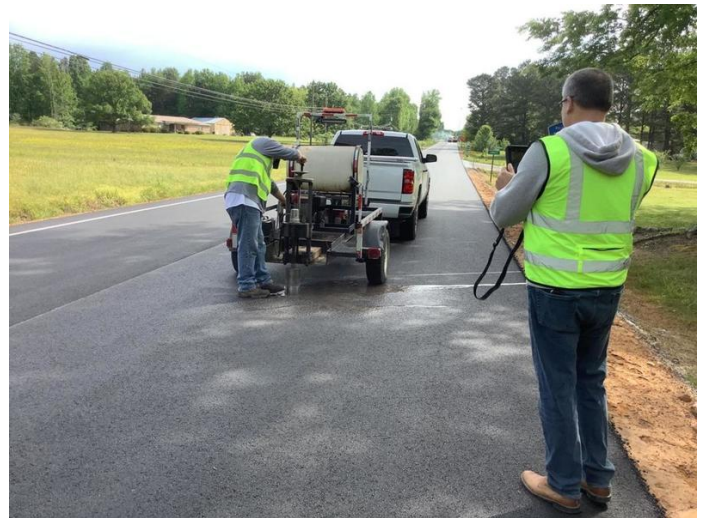
Cutting Cores

Cores were taken in 500' intervals for this project. The bond strengths averaged over 200psi, proving that the trackless tack provided a very strong bond between the pavement layers. The minimum passing for core bond strengths is 100psi.

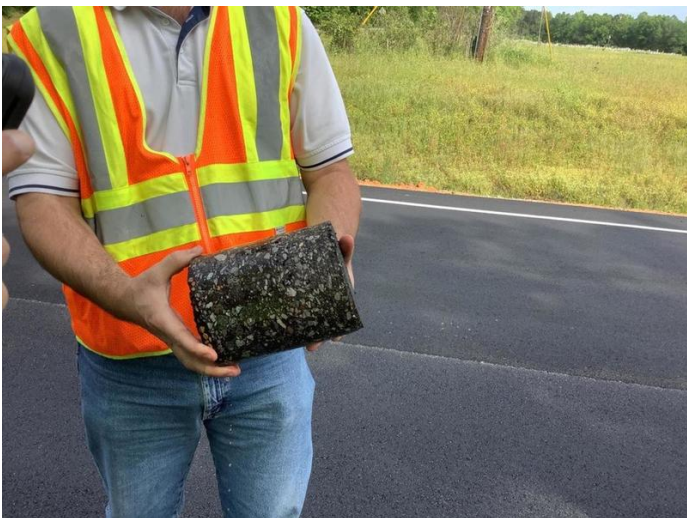
Core Cut showing tack bonded Pavement Layers

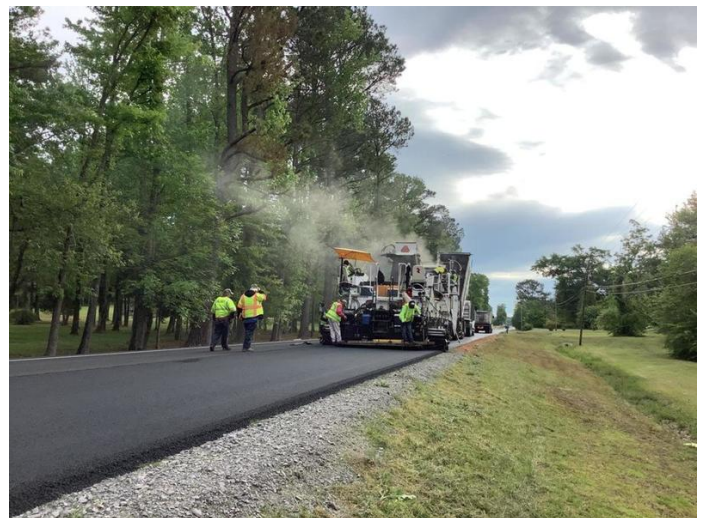
Paving Hot Mix

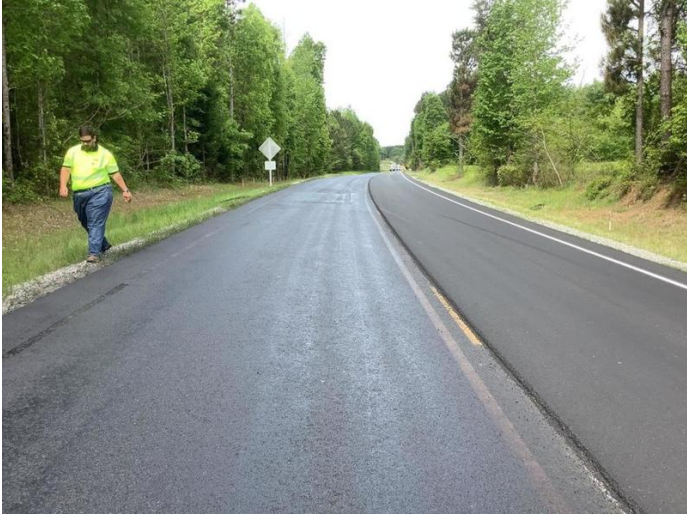
Perfect Uniform Coverage of Broken Trackless Tack
