This trackless bond coat was shot for ALDOT on SR-102 in Walker County. Full proper coverage of bond coat and quick return to paving are features for this treatment.

The project is located on SR-102 in Walker County. This is located in the ALDOT West Central Region. The weather started off in the mid 50s and rose to the low 70s.

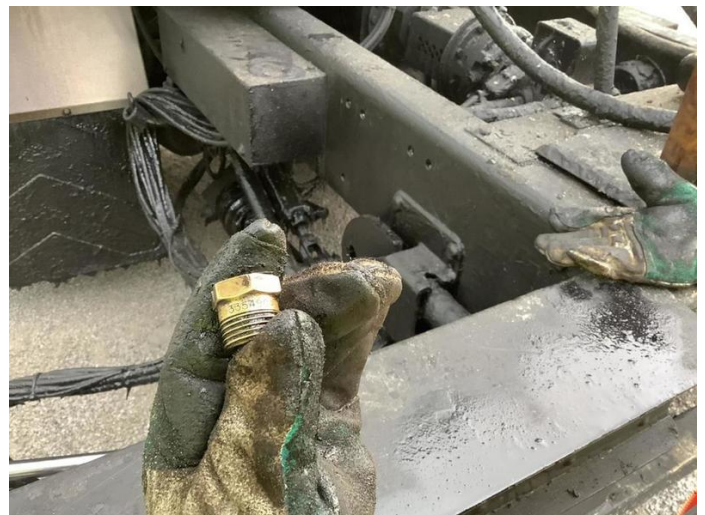
Correct Nozzle Size #3354904 which is a #1 nozzle

The Trackless tack was shot at 0.08gal/sy. The contractor used an Etnyre Distributor with #1 nozzles. Etnyre says this size nozzle can shoot a rate of 0.05-0.20gal/sy. The correct nozzle size used on this project, provided great uniform coverage of the bond coat throughout the project. This would prove essential to bond the pavements so that layers would perform as one monolithic pavement.

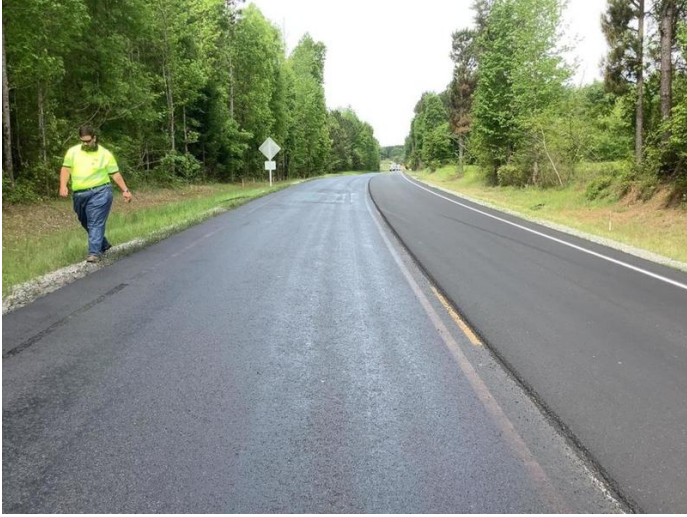
Perfect Uniform Coverage of Broken Trackless Tack
