This trackless bond coat was shot for ALDOT on SR-102 in Walker County. Full proper coverage of bond coat and quick return to paving are features for this treatment.

BACKSTORY:

The project is located on SR-102 in Walker County. This is located in the ALDOT West Central Region. The weather started off in the mid 50s and rose to the low 70s.

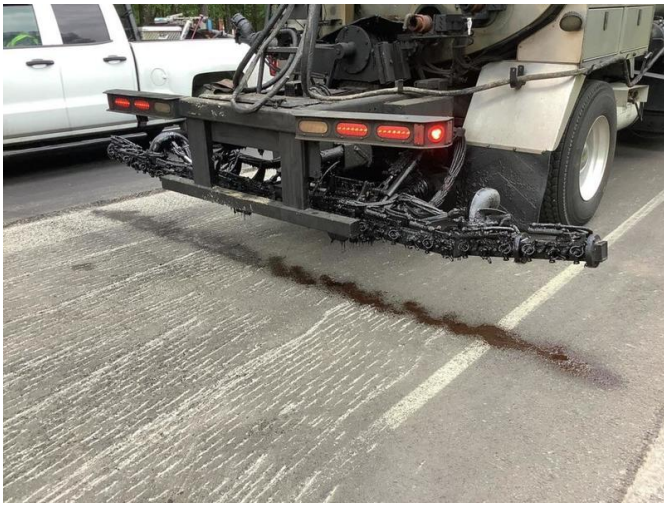
Prior to shooting trackless tack and checking each nozzle.

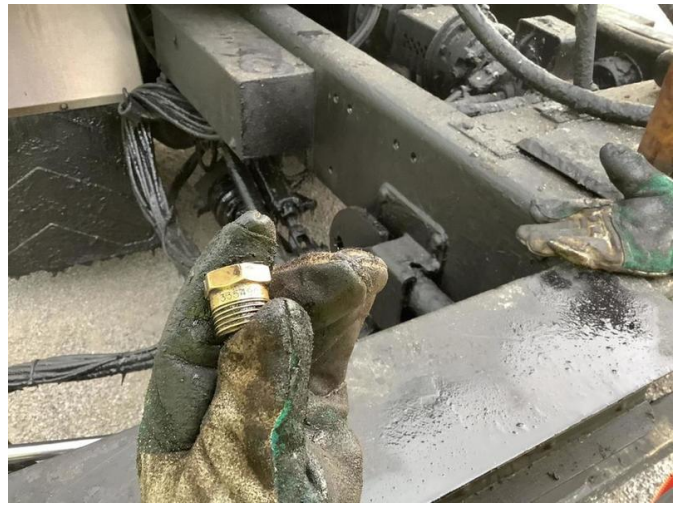
Correct Nozzle Size #3354904 which is a #1 nozzle

The Trackless tack was shot at 0.08gal/sy. The contractor used an Etnyre Distributor with #1 nozzles. Etnyre says this size nozzle can shoot a rate of 0.05-0.20gal/sy. The correct nozzle size used on this project, provided great uniform coverage of the bond coat throughout the project. This would prove essential to bond the pavements so that layers would perform as one monolithic pavement.

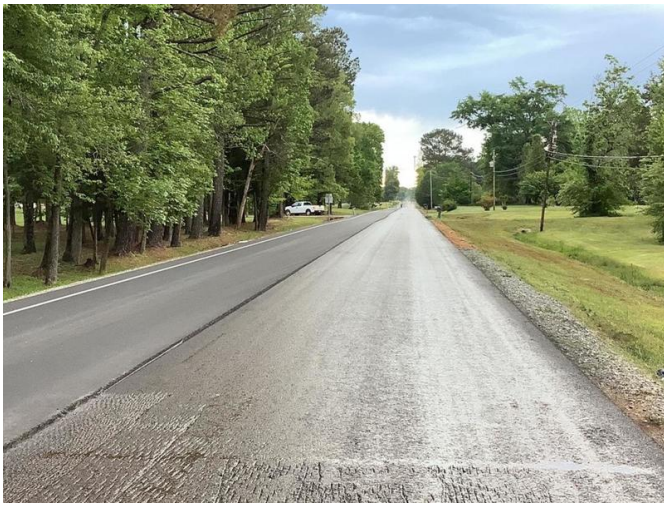
Uniform Shot Rate (Not Broken)

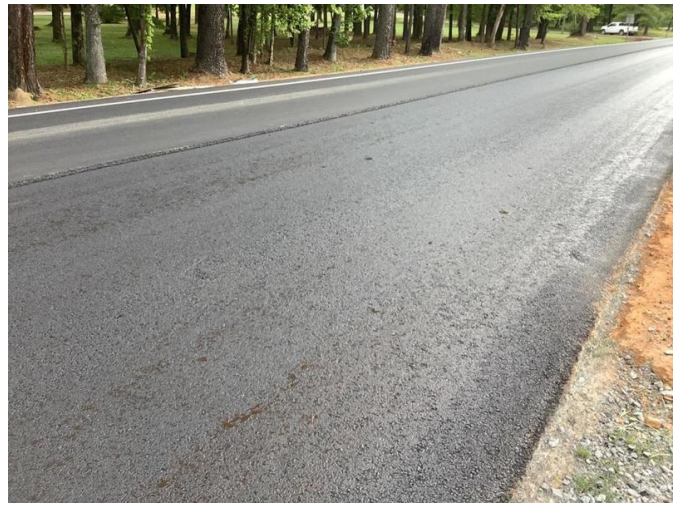
Broken Tack (Uniform Coverage)

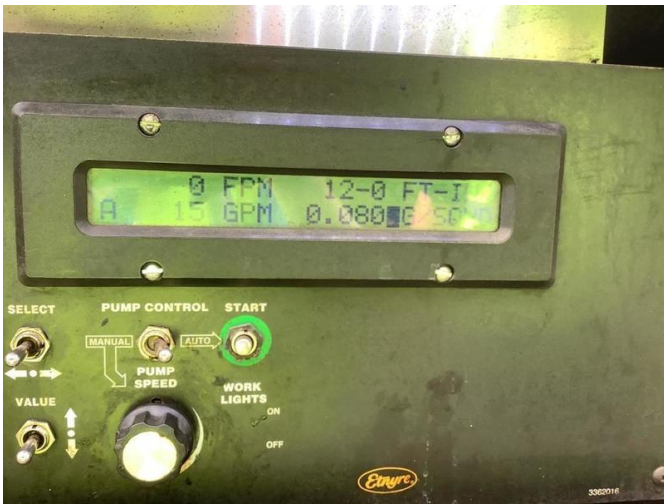
Shot Rate on Distributor Computer 0.08gal/sy

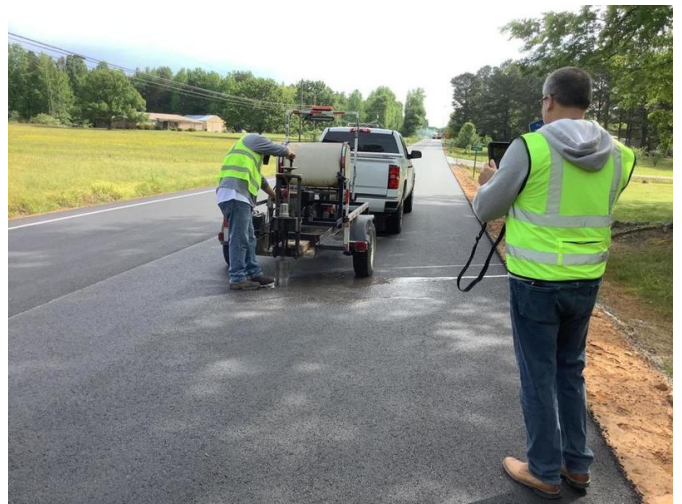
Cutting Cores

Cores were taken in 500' intervals for this project. The bond strengths averaged over 200psi, proving that the trackless tack provided a very strong bond between the pavement layers. The minimum passing for core bond strengths is 100psi.

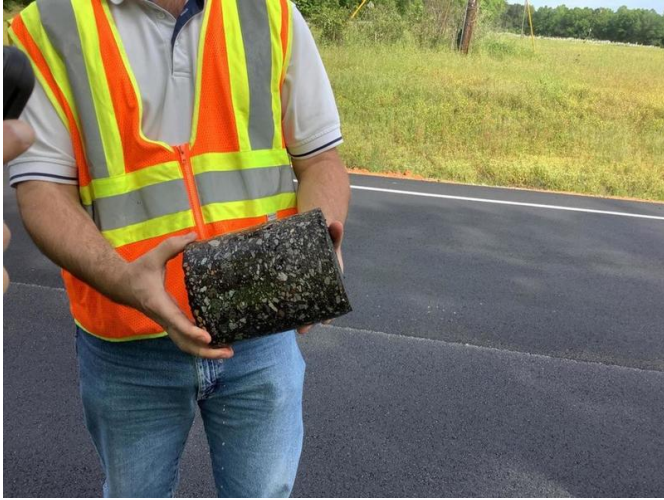
Core Cut showing tack bonded Pavement Layers

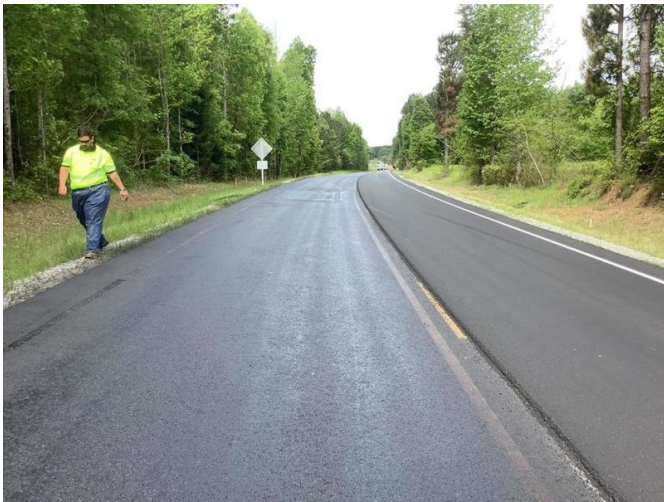
Perfect Uniform Coverage of Broken Trackless Tack
