Repairing the Road to Zion National Park with Scrub Seal & Micro Surfacing

Crews work day and night to save Utah's S.R. 9, implementing Utah's first application of scrub seal in over 30 years and saving UDOT \$80,000 per mile.

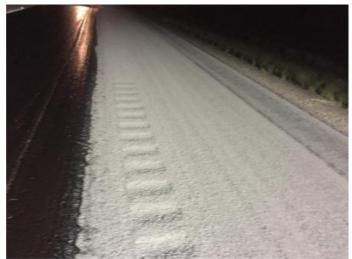
Ramps before construction

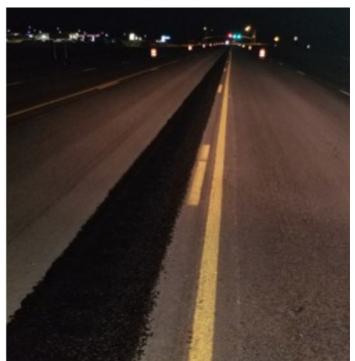
Scrub Seal night application

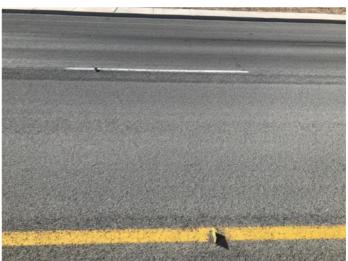
Micro Surfacing type iii aggregate
