Victoria, Australia utilizes pavement preservation techniques for higher quality roads, supporting heavy traffic, with a lower project cost.

BACKSTORY:

A section of arterial road in Benalla, Victoria experiences a heavy flow of both commercial and residential traffic, with more than 9,000 vehicles per day. The wear and tear from the high volume of traffic, and the turning and torque of heavy vehicles required a massive maintenance program to repair and extend their lifespan.

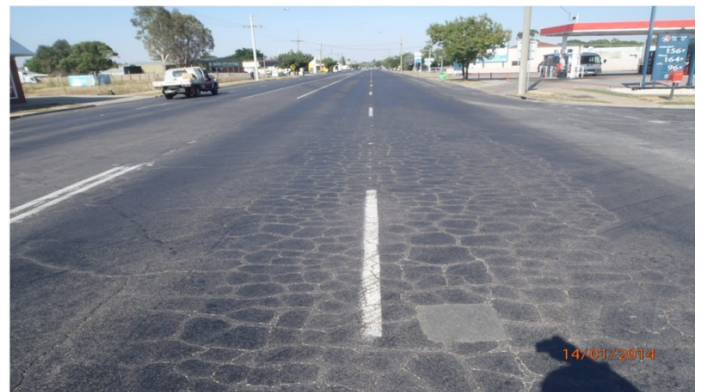
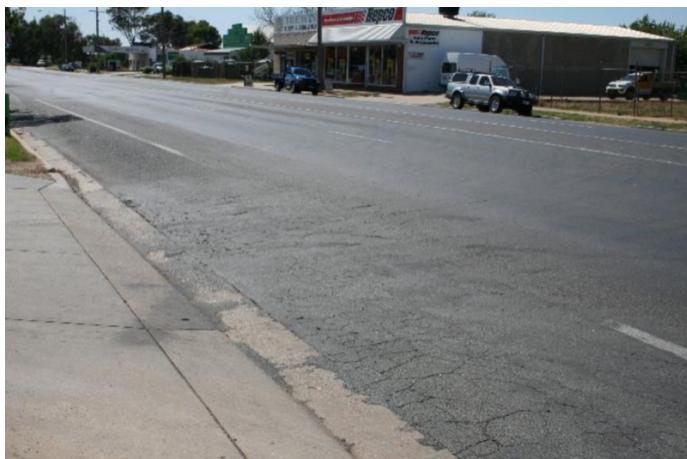
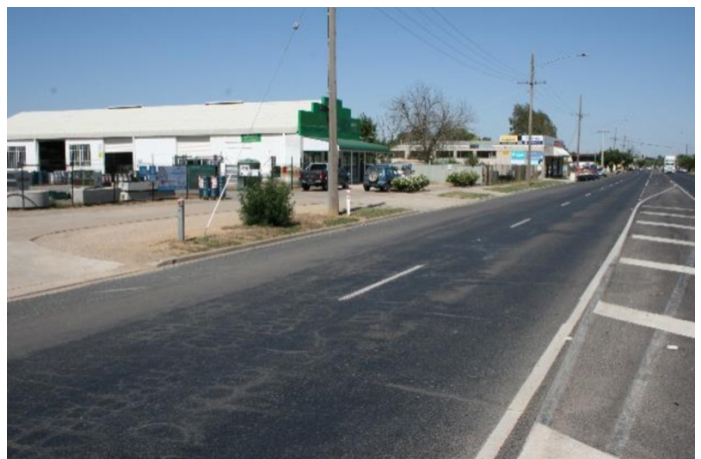
Pre-existing Condition - January 2014

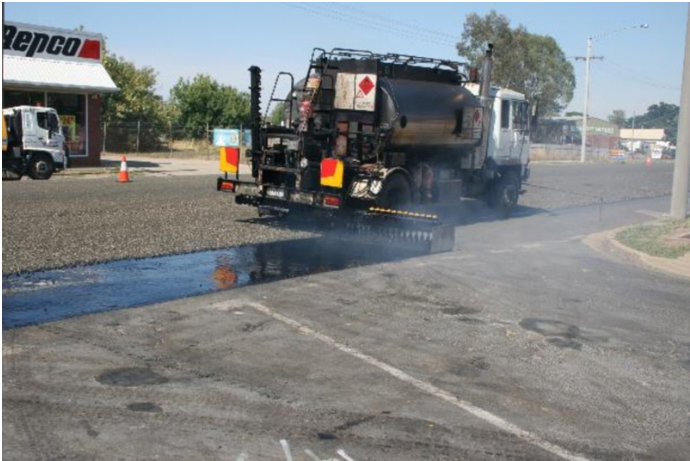
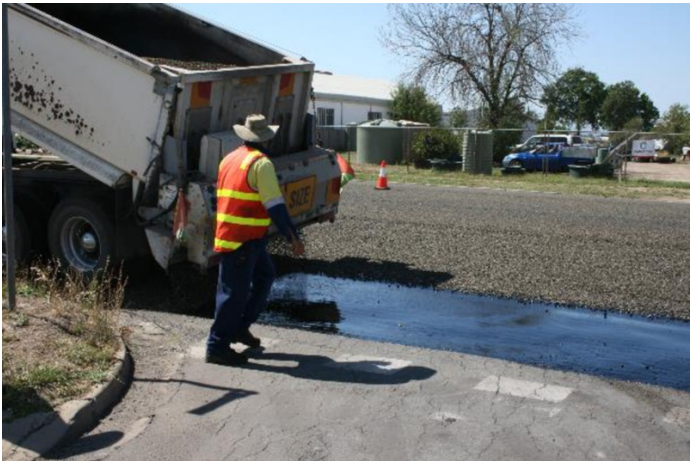
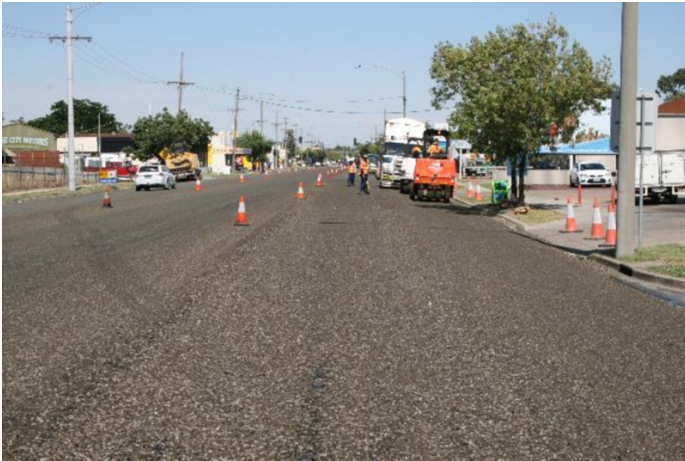
Installing the seal February 2014

North Eastern Maintenance Alliance teamed with Downer Group to provide a preservation treatment using a Polymer Modified Binder (PMB) Spray Seal, overlaid with a Microsurfacing SFT (Suspended Fibre Technology) Cape Seal, cutting expenses, emissions and time. This type of treatment provided a cost effective, highly flexible, waterproof film coupled with a hard wearing surface to accommodate high volumes of vehicles, turning traffic and sound reduction. Six years after completion, the road is maintaining a high condition with minimal wear.

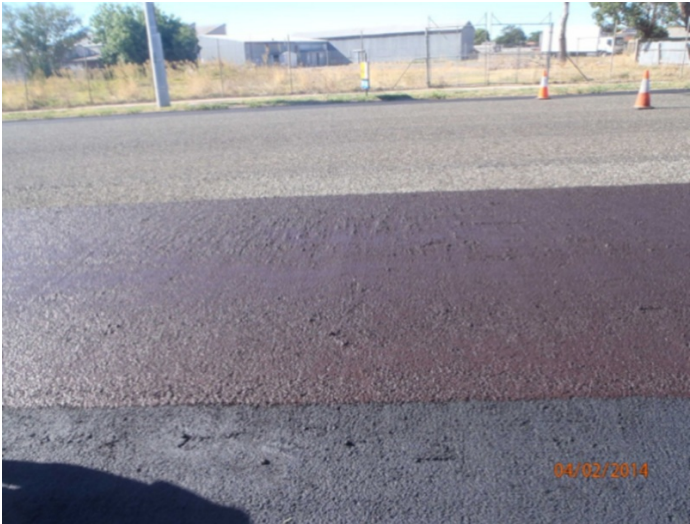
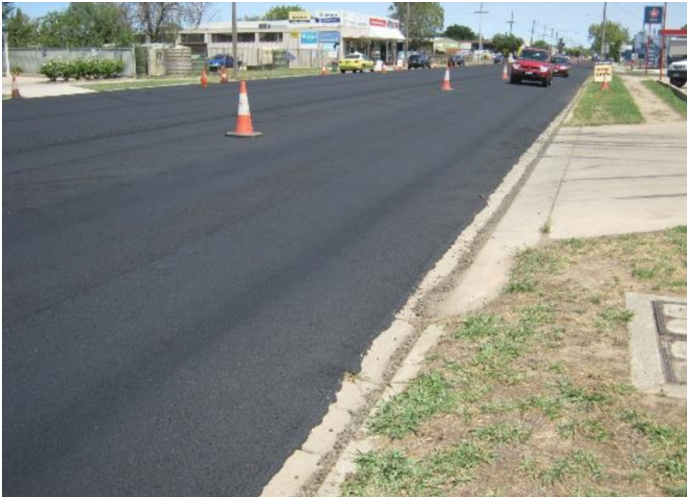
Installing the Micro Surfacing
