CIR Revitalizes Colorado Mountain Pass. See the full article by ASPHALTPRO staff at:

CIR Revitalizes Colorado Mountain Pass

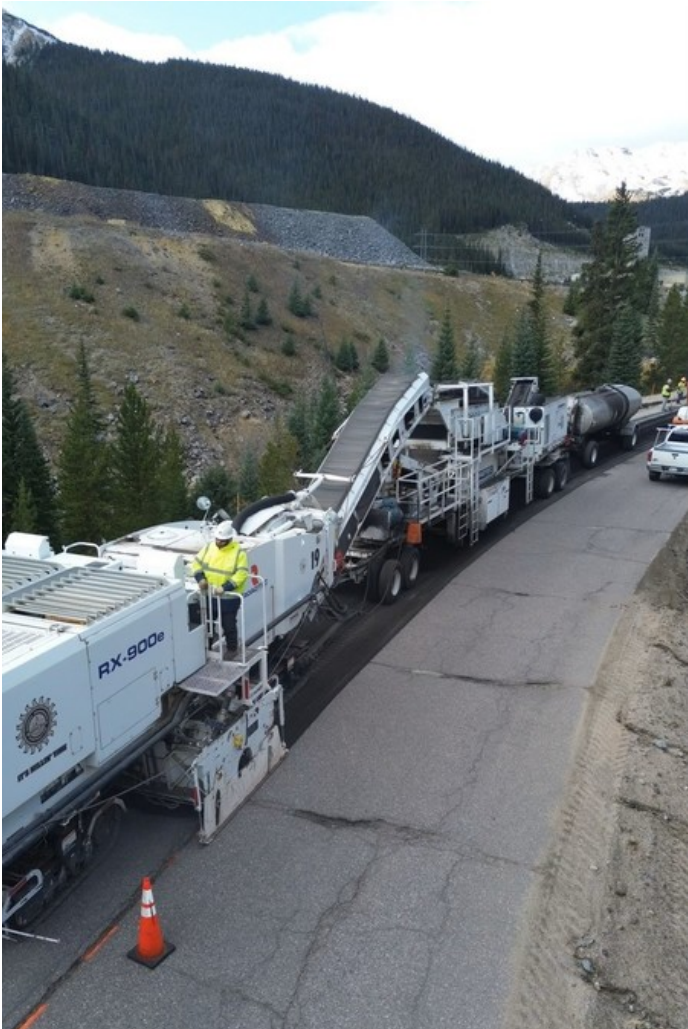
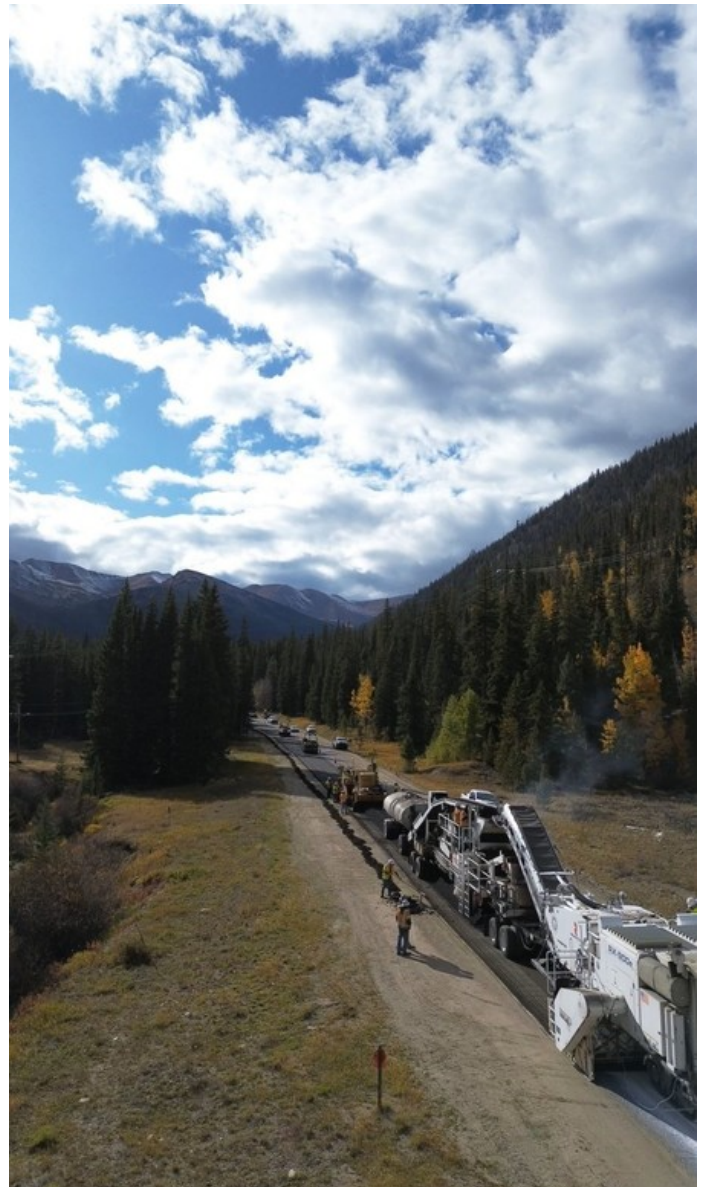
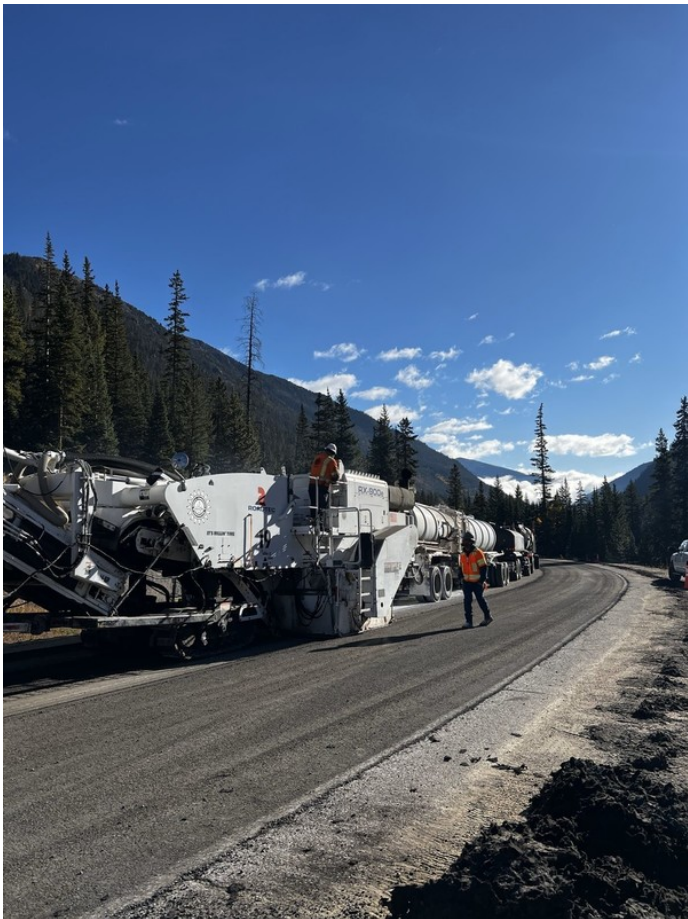
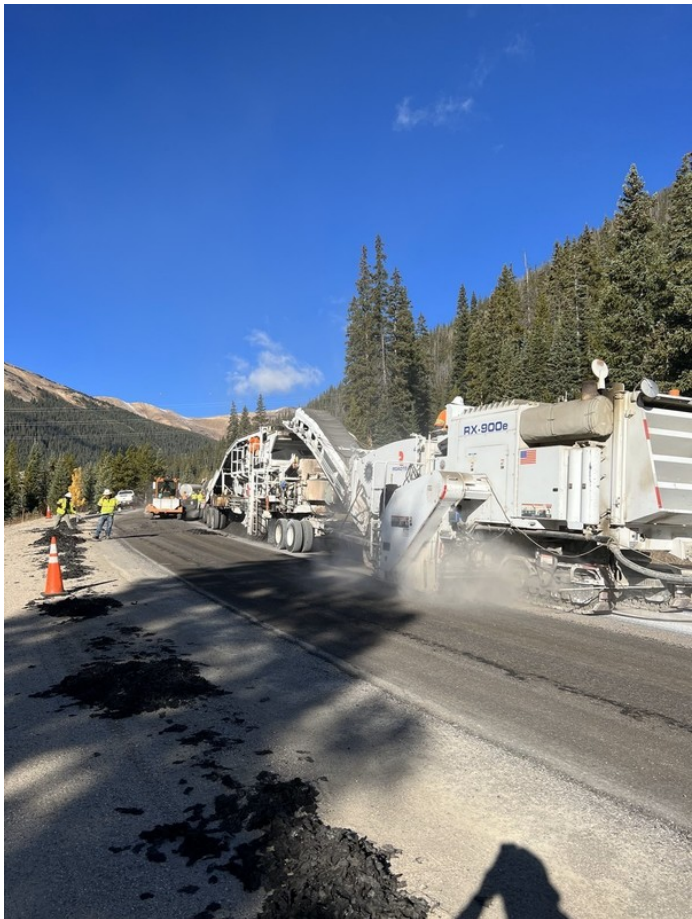
PHOTOS:

Although only 1.75 miles in length, Jones Pass Road sees heavy truck traffic which had resulted in severe age-related distress including potholes, alligator cracking as well as transverse and longitudinal cracking. The remote location and high altitude presented additional challenges. Creek County was looking for a cost effective, sustainable solution for rehabilitation.

Atlas Austin, Texas was hired for engineering and design of the project for Creek County. CIR was selected for the design based on the condition of the road, as well as the cost savings and the reduction in material import/export compared to full removal and replacement. The selected design consisted of a 4-inch CIR followed by 5 inches of new hot mix asphalt (HMA). APC was the general contractor and APC Southern, a sister company with experience with CIR projects, paved the project. Coughlin Company, a SurfaceCycle company, performed the CIR using their Roadtec RX900e mill followed by their Roadtec RT500 recycling train. Atlas performed the CIR mix design and handled the CIR quality control. The CIR mix contained 3.5% engineered emulsion supplied by Suncor and 1.5% quicklime from Lhoist, applied as a slurry. Although an unexpected paving fabric was encountered during CIR construction, production was not affected, and the CIR portion of the project was completed in two weeks. Extra personnel were required to remove fabric from the screening deck. Creek County reported they were pleased with the completed project and hope they have extended the service life of the road surface by another 20 years.
