Contractor successfully repaired Lake Louise Marie Road in the Town of Thompson located in Sullivan County New York. Fiber reinforced interlayer with a Paver Placed Surface Treatment overlay.

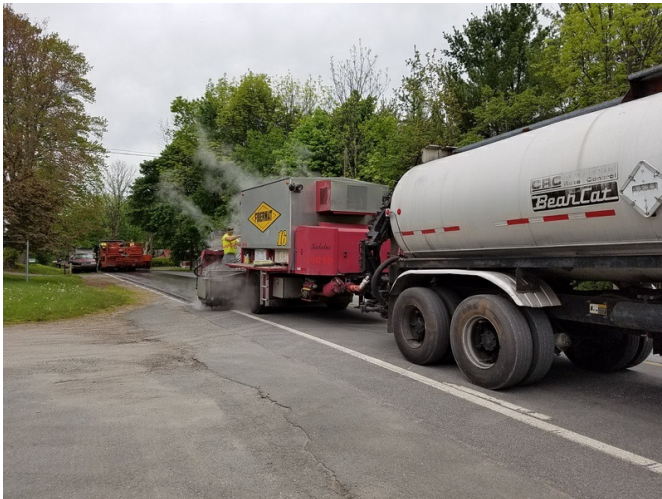
The Gorman Group laying interlayer fiber reinforced system

With the town working on a low dollar budget and in a high traffic area, the fiber reinforced interlayer was selected to reinforce the pavement in preparation for surface overlay. The Paver Placed Surface Treatment was selected (PPST Type B) to provided a high friction surface wearing course. With busy intersections and high volume from local businsses this project has out performed prior traditional hot mix overlay. This two part pavement preservation system has in turn resulted in revitalizing a deteriorating road back to life for years to come.

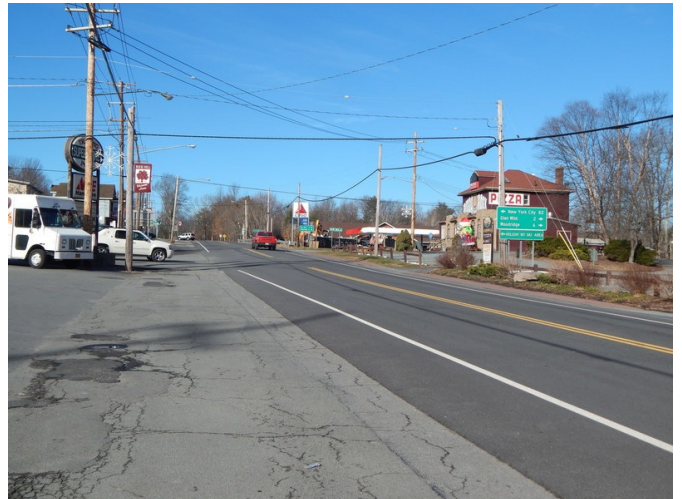
Lake Louise Marie Road finished with PPST Type B

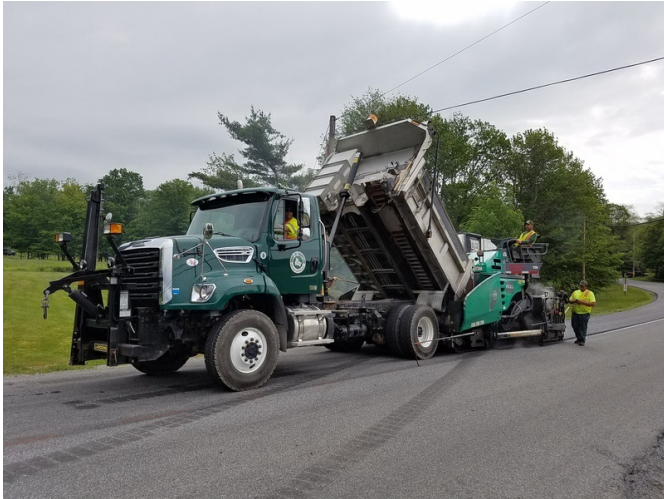
The Gorman Group paving with PPST Type B, utilizing the Town of Thompson to haul material

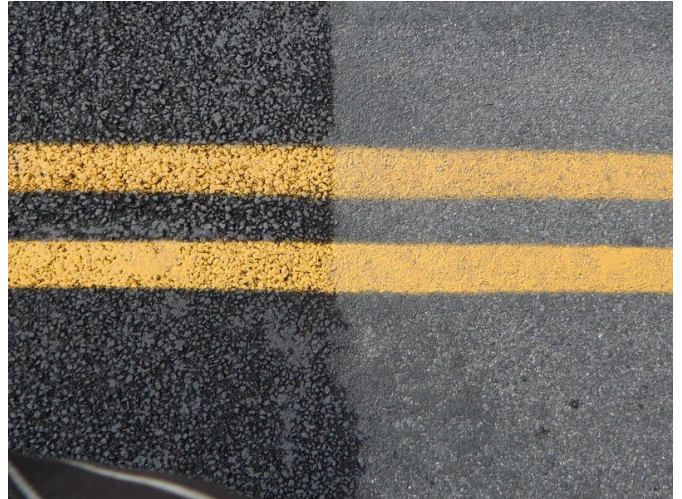
Finished Surface comparison - fiber reinforced interlayer with chip finish on right / PPST Overlay Finish on left
