Cook County needed to rebuild 2 miles of deteriorating roadway, representing 27,000 square yards of road surface in the city of Orland Park. The existing pozzolanic base was rigid and contributing to reflective cracking, which meant that a simple asphalt overlay would not provide the best long term outcome.

#### BACKSTORY:

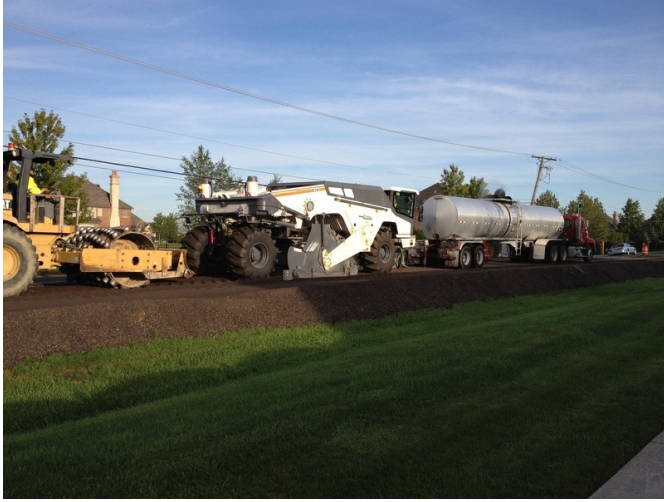
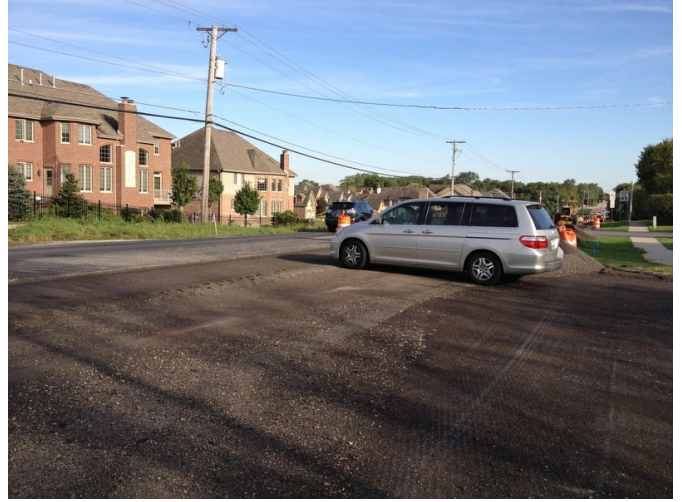
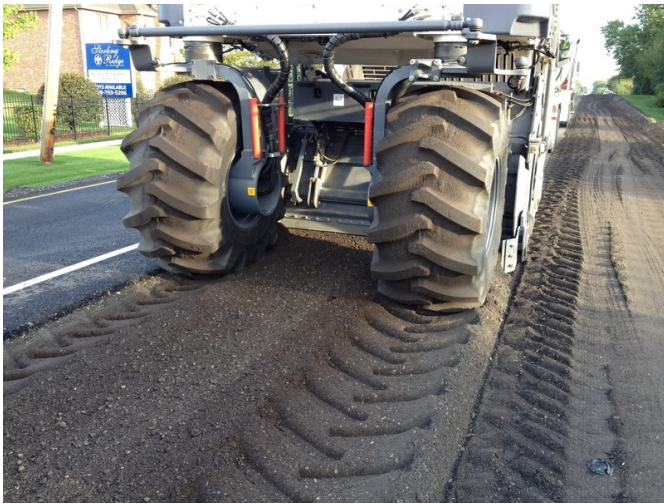
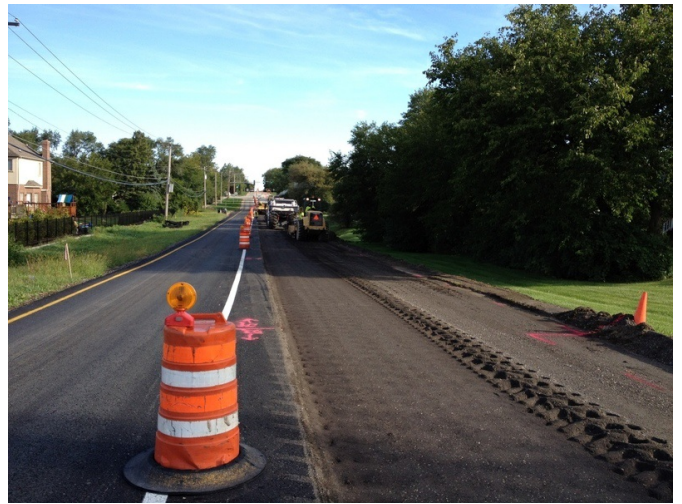
#### PHOTOS:

After consideration of all the available options, full-depth reclamation was chosen over a more traditional remove and replace approach because it meant that deep, underlying pavement problems could be resolved and structural performance targets met at a fraction of the cost.

Core samples of the pavement were obtained to perform mix designs that addressed the challenges of the inconsistent subgrade and varying pavement width. Throughout the project, the contractor employed quality control processes that included having field representatives on-site, performing moisture content and field density testing to ensure all structural property targets were verified upon completion of construction.
