NIMC erases \$38,000 change order and improves strength of it's new entrance road with Soil Stabilization.

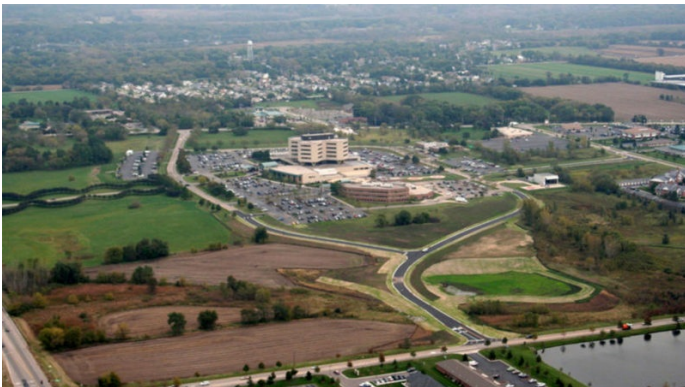
Aerial View of NIMC and new entrance road

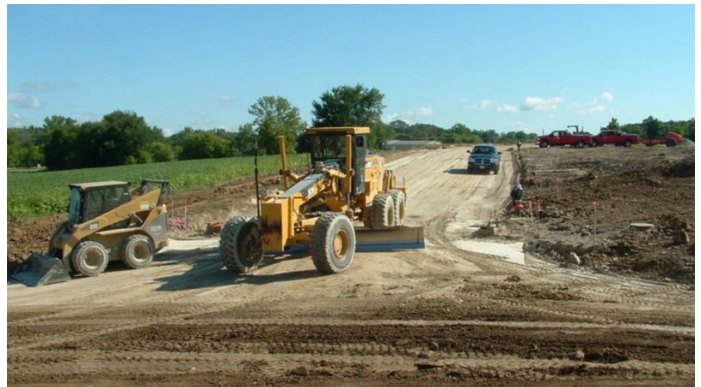
Final grading to elevation

By utilizing soil stabilization as an alternative method, Rock Solid was able to produce a uniform subgrade for the entire road that cost no more than conservative estimates of the original proposal. Careful testing and analysis allowed them to design a fly ash stabilized soil mixture, improving the strength and reducing the shrink/swell potential of the on site soils.

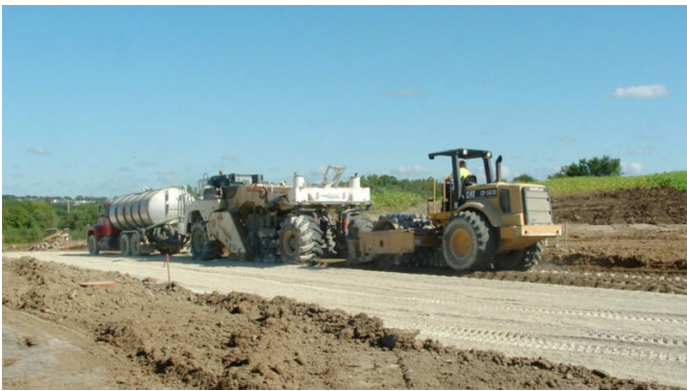
Initial compaction after tilling

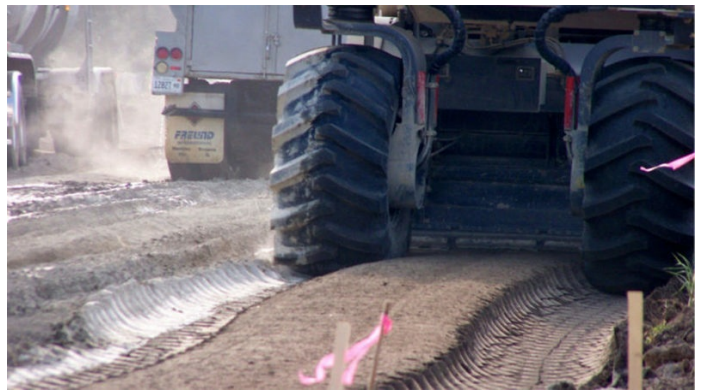
Uniformly tilled material

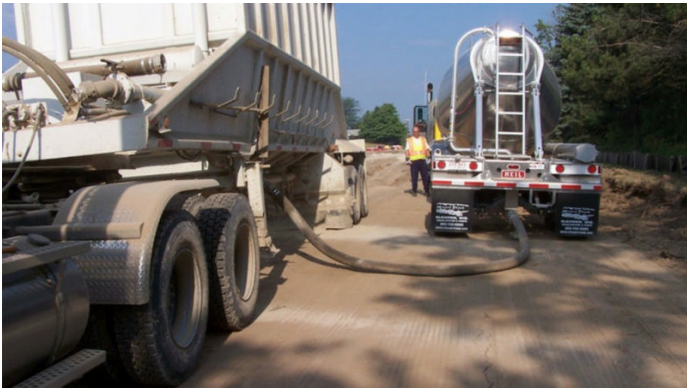
Pneumatic bulker loading spreader truck
